CONSIDERATIONS CONCERNING THE HYDRAULIC YIELD OF IRRIGATION PLOTS UNDER PRESSURE

*PhD.eng. ALEXANDRU - LUCIAN LUCA, Polias - Instal Company, Iași Romania
Stud.PhD.eng. ȘTEFAN - ANDREI STICEA, Profesor, PhD.eng. MIHAIL LUCA
Technical University "Gheorghe Asachi" of Iași, Romania*

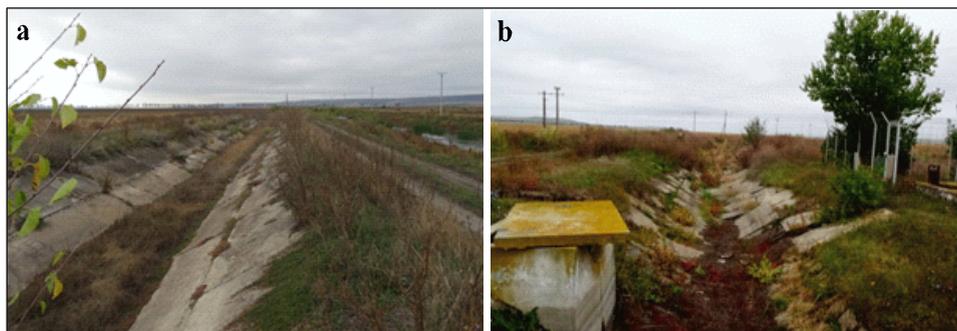
The studies and research carried out within the irrigation plots SPP 16 Berezeni, SPP7 Doniceasa - Fălciu and SPP O etoiaia, components of the "Albița - Fălciu Complex Management" highlighted significant water losses in the network of canals and pipes (Luca, 2015, Luca 2016). The irrigation plots in the meadow area are fed through one or two distribution channels. The structural state of the channels has a high degree of degradation, an aspect highlighted by the field research carried out in the period 2011 - 2019. The channels are executed in the well and are protected with a layer of reinforced concrete slabs, where the joints are filled with cement mortar. This process reduces water leakage through infiltration into the foundation land. The degree of degradation of the concrete slab lining is variable along the channel length, from 30 - 40% on central sections, to 80 - 100% in the area of the pumping stations (Fig. 2).

Fig. 2 - State of the supply channel of SPP Oțetoaia, year 2019, Vaslui county
a - degraded reinforced concrete slabs and mortar joints; **b** - reinforced concrete slabs totally degraded and displaced from the slope in the SPP area (Photo Luca, 2019)

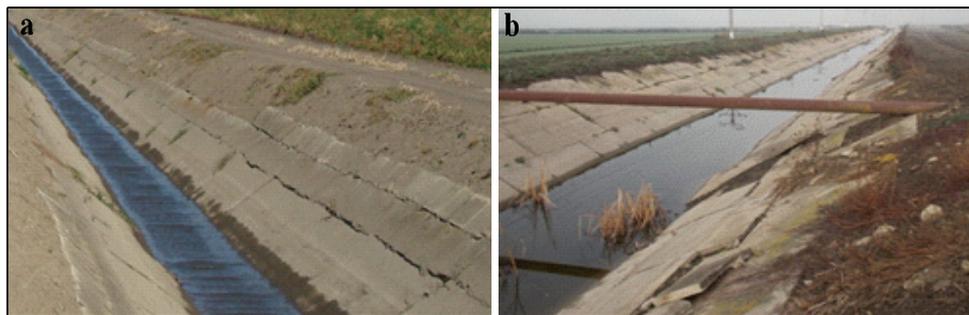
county, a degradation of the surface protected by concrete slabs. The slabs are degraded by cracking and cracking, by expelling the mortar from joints, by breaking them and sliding on the slope (Fig. 3). Research has shown the production of significant water losses in the network of canals and pipes [Luca, 2012].

Fig. 3. The state of degradation of the supply channel of SPP1b Sud Soloneț, Iași county
 a - cracked slabs and mortar removed; b - reinforced concrete slabs totally degraded and displaced from the slope (Luca, 2012)

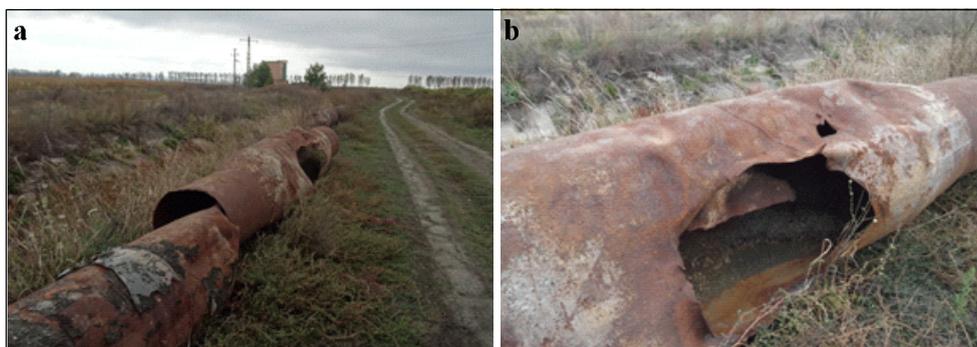
The main pipes in the irrigation plots equipped with SPP are made of reinforced concrete tubes (PREMO type) and steel pipes. The research carried out in the field (SPP1b Sud - Soloneț, SPP16 Berezeni, SPP7 Doniceasa Fălciu, SPP Oțetoaia etc) showed the degradation by chemical corrosion of the main pipes made of steel. The replaced pipe sections showed the total non-functional state of the main pipes with a diameter of 500 - 600 mm made of steel sheet (Fig. 4).

Fig. 4. Condition of the main pipe (Dn 600 steel) at SPP Oțetoaia, year 2019, Vaslui county
 a - section of pipe replaced; b - detail regarding the structural degradation of the steel pipe (Photo Luca, 2019)

Exceeding the service life of the pipes and degradation of the inner and outer protection layer favoured the formation of holes and cracks in the pipe walls. This situation led to large water losses, which led to the reduction of the hydraulic efficiency of the main pipe.

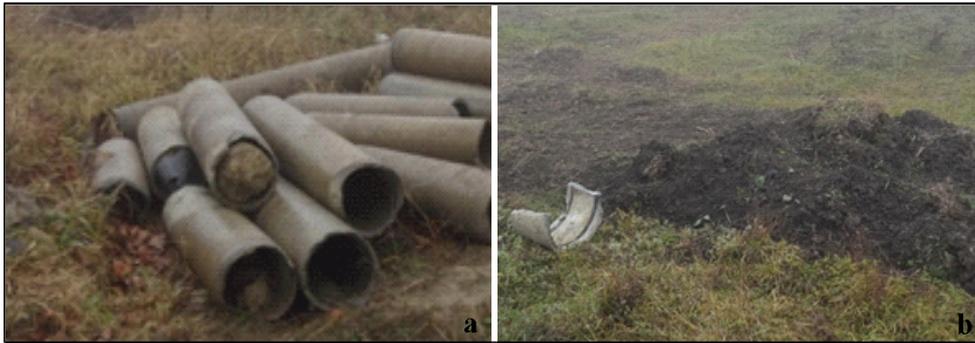
Secondary pipes are generally made of blast pipes. Pipes of this type are greatly degraded by accidental pressure variation in the system (hydraulic shock). Most faults occur in the area of the jacks and bypasses. The aging of the rubber gasket determines the appearance of local and diffuse water losses, an aspect highlighted in the plot SPP16 Berezeni (Fig. 5) [Luca, 2015].

Fig. 5. State of distribution pipes (abasement) from plot SPP16 Berezeni, Vaslui county, year 2015

a - changed degraded pipes; b - damage by breaking the plug (photo Luca M.)

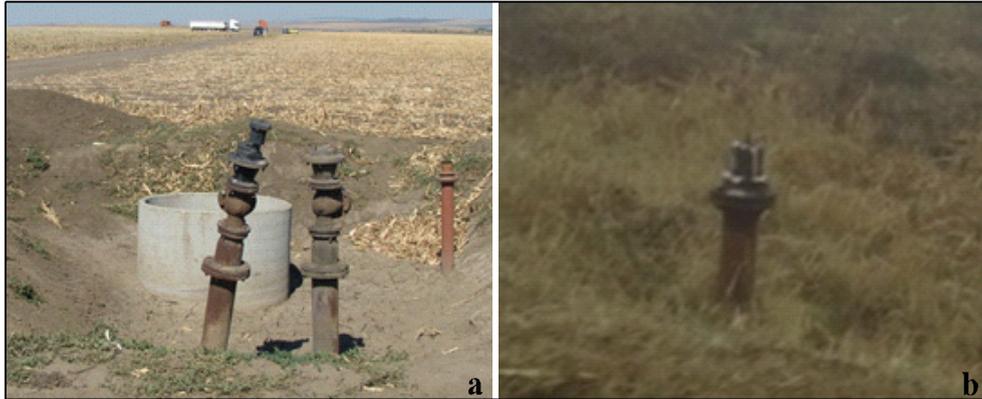
The condition of the hydraulic installations in the fireplaces, as well as the hydrants was influenced by the degree of wear and the absence of maintenance and rehabilitation works (Fig. 7).

Fig. 7. The state of degradation of the hydraulic installations from irrigation plots
 a - the state of the ventilation installations on the main pipe in the plot SPP1b, South-Soloneț Iasi county, year 2012; b - status of hydrants in plot SPP7 Berezeni, Vaslui county, year 2015 (photo Luca M.)

- total degradation, which causes water losses at the closing device;
- constructions on the network: bypass shelters, ventilation sheds (Fig. 7a), massive drainage sheds, anchorages, sub-crossings, etc .; the fireplaces with hydraulic installations were made of reinforced concrete and concrete pipes, which favoured their degradation over time; the hydraulic system has the period of operation exceeded, and its components are degraded in a proportion of 70-80%.

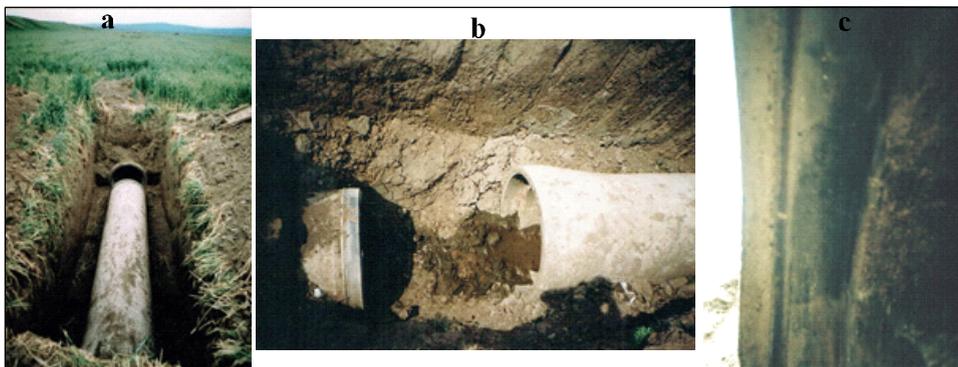
Fig. 8. Analysis of the degradation state of the PREMOTubes mounted on pressure pipes
 a - tube Dn 800 unscrewed; b - detail regarding the state of the tube joint; c - detail regarding the trace related to the rubber gasket pressed unevenly in the tube socket (photo Luca M., 2012)

(SPP1b) on the main pipe (CP2b), favoured by the high and continuous pressure on the secondary pipes. Pipes made from PREMO tubes show significant water leakage at the socket due to aging of the rubber gasket. The same phenomenon also occurs in pipes made from azure cement tubes, where the socket is degraded by pressure variations. PVC pipes are degraded by the appearance of cracks and cracks in the wall of the tube caused by exceeding the period of exploitation of the material.

The use of pipes for a limited time (irrigation season), when their section is full, favours the degradation of the gaskets. The pipes are drained outside the irrigation season, which causes an asymmetrical action on the rubber lining: maximum pressure at the bottom of the socket and no pressure at the top. This situation causes a change in the behaviour of the gasket over time.
