## RESEARCH ON THE DEGRADATION OF PIPELINES POSITIONED IN THE UNDERCROSSING OF RIVERS

*Prof.PhD.eng. MIHAIL LUCA,  
stud. PhD PETRU-DANIEL BRANIANU, stud. PhD PETRONEL-IONUȚ ROMANESCU  
Technical University „Gheorghe Asachi” of Iași, Romania*

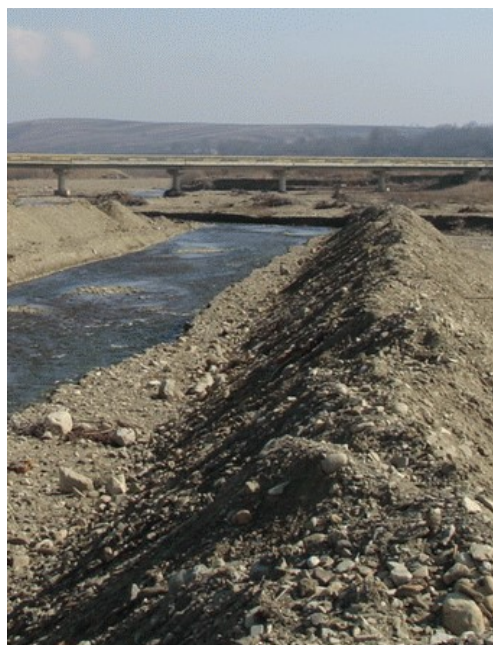
Fig 3. The reprofiled bed of the Tazlaur Sarat River in the research area (Luca M., 2017)

Bacău County [Fig. 3]. The river bed moved horizontally and created new flow paths. One of the routes moved towards the right bank, which it eroded over a length of about 300 m [W.B.A. Siret, 2016]. In the eroded area there is a supply pipe that transports drinking water. This pipeline supplies a number of localities in Bacău county and mainly the city of Bacău. From the data presented by W.B.A., Siret [2016] identified 350 m of eroded bank in the pipeline location area [Fig. 4].

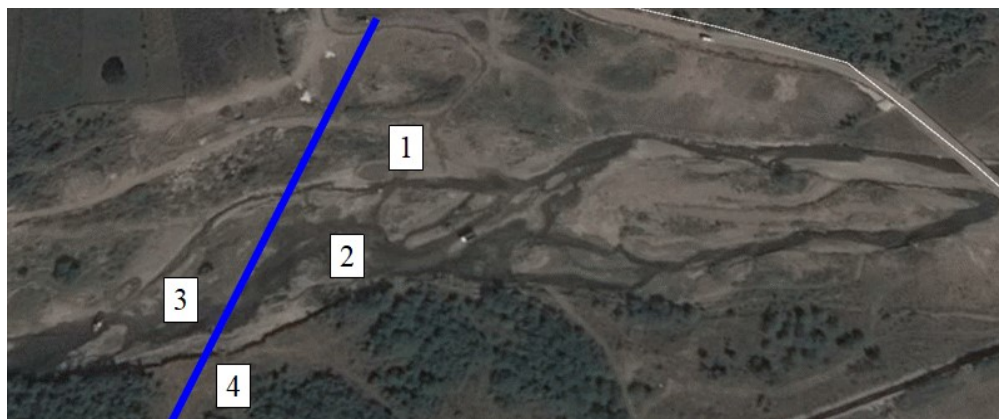
Fig. 4. The state of the bed of the Tazlaul Sarat River in the research area after the flood:  
1 – old bed; 2 – new bed created during the flood; 3 – the undercrossing area;  
4 –adduction pipe (Google earth image 2017)

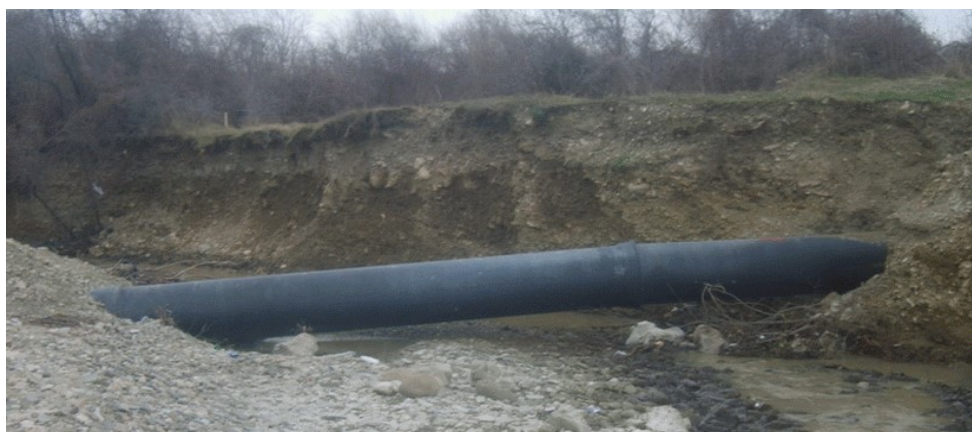
The objective considered in the research is a section of the adduction pipeline that transports drinking water from the Darmanesti Treatment Station to the city of Bacau. The pipeline is 64 km long and is made of PREMO [pre-compressed reinforced concrete] tubes with a diameter of 1000 mm. The section in the undercrossing of the Tazlaul Sarat River is made of pressure cast iron tubes with an internal diameter of 800 mm. The installation of the undercrossing pipe is according to the second variant presented previously. The analysis carried out in the field did not reveal the presence of an anchoring massif in the eroded shore, as well as protective constructions against the hydrodynamic action of water [protection elements, fixing constructions, support constructions (Fig. 5) [Luca M, 2017 ]. It is possible that some of these components were

Fig. 5. The state of degradation of the adduction pipe site in the area of the bank right of the Tazlaul Sarat River from the outskirts of the Moinesti city (Luca M., 2017)

The research carried out in the field revealed the extent of the erosion of the right bank in the area where the adduction pipeline is located. The erosion of the bank advanced in the riparian zone and caused the pipeline to be uncovered and subsequently suspended by washing away the rock support layer [Fig. 5 and Fig. 6.a].

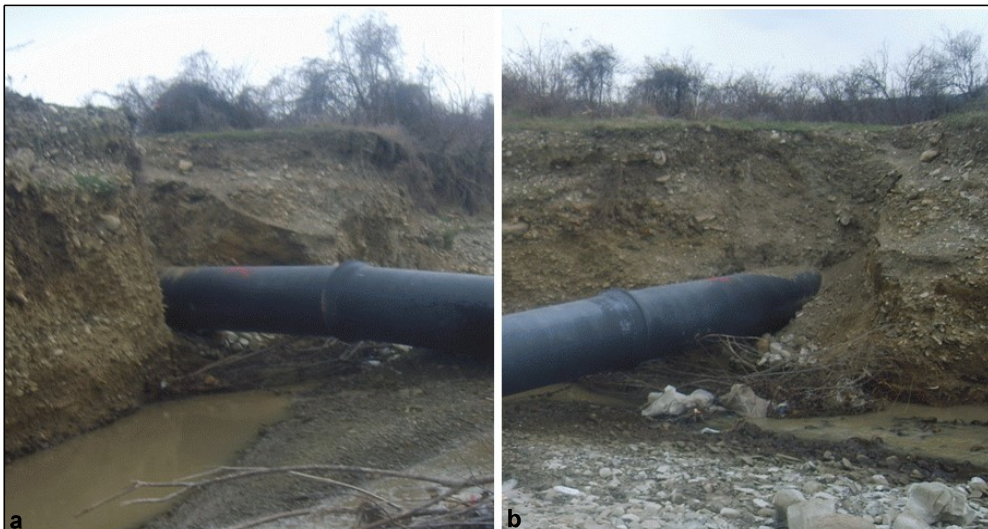
The erosion effort given by the water speed is exerted on the perimeter surface of the bed. Its maximum value is recorded in the zone of maximum depths, respectively at the bottom of the bed. In general, at the waterline where the water height is higher, the maximum erosion depths occur and develop. In the case of under-crossing pipes, their uncovering begins in the zone of maximum depths. In the investigated case on the Tazlaur Sarat River, the exposure of the adduction pipe took place near the bank, continued in the bank and in the riparian area [Fig. 6].

The result of the erosion of the bank led to the suspension of the adduction pipeline for a length of about 15-20 m. The erosion of the right bank was accelerated, in particular, by the movement of the bed towards the right bank, a situation in which a new flow arm was created. The loss of bank stability was favoured by flood parameters [high velocity, high water height] and geotechnical characteristics of the bed [alluvial ballast layers, dusty sands and gravel intercalations]. The right bank reached heights of 3.50 – 4.50 m compared to the bottom of the new bed (Fig. 6). The erosion continued under the lower generator of the adduction pipe, right in the joint area represented by a plug, a situation that can generate an accident (Fig. 6.b).

The advance of the bed into the bank was also determined by the curvature of the new arm created by the flood, where the concave part was positioned in the undercrossing entry area of the adduction pipe. The infiltration of water along the pipeline placed in the bank favoured the expansion of the phenomenon of erosion in the riparian zone.

Fig. 6. Bank erosion on the Tazlaur Sarat River in June 2016, with the advance on the bank and the suspension of the adduction pipeline in the Moinesti area: a – downstream view; b – upstream view (Luca, 2017)

The importance of the adduction pipeline in the regional water supply system of Bacau County required the immediate taking of measures to ensure the stability of the pipeline and its safe operation. For this, a series of works were designed and executed to bring the riverbed back on a route that would protect the undercrossing area of the adduction pipeline.

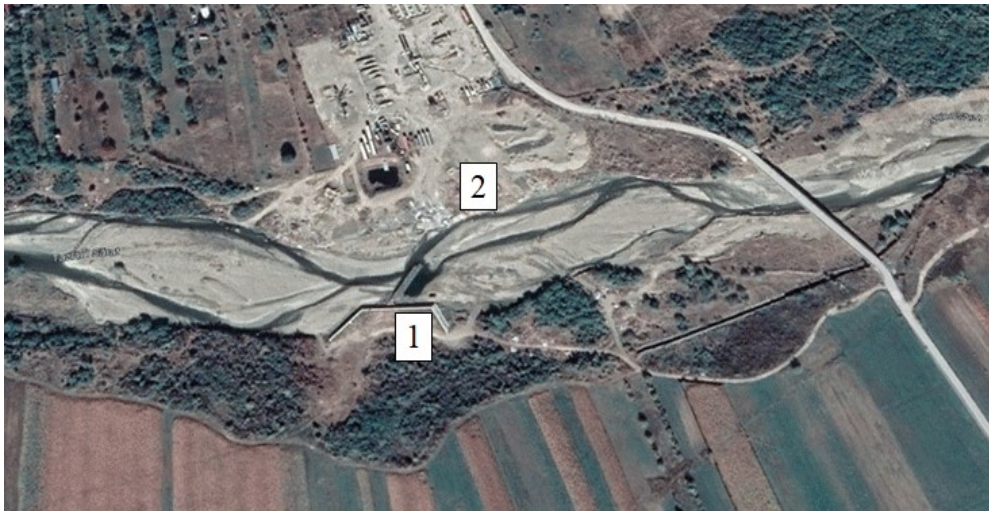
Fig. 8. View of the location area of the works carried out in the bed of the Tazlaur Sarat River at the eastern limit of the Moinesti city: 1 – protection of the bank with the location of the pipeline; 2 – the new bed of the river (sc. 1:100000 image Google earth 2023)

Work was also carried out to fix the pipeline near the bank, where the location area was eroded, as well as in the bed [Fig. 8]. These works were made of gabion mattresses filled with stone. Considering the category of importance of the hydraulic installation located in the undercrossing and the negative conditions in the site (highly erodible river bed) (Fig. 7.a), a series of additional works had to be added to ensure the protection and stability of the adduction pipe.

The bank protection work was extended to different lengths upstream, downstream and in the bed of the pipeline site (Fig. 8). The protection work on the entrance area of the pipeline in the undercrossing was made of retaining walls made

The gabion structure advances in the river bed in the form of an unsinkable dike to direct the water current towards the axis of the original bed (Fig. 8).

The main riverbed was restoration, shaped and sized to accommodate the flood flows. The new bed is 300 m long and is at a safe distance from the protected bank where the adduction pipe is located. From the analysis of the Google Earth image taken in 2016, the movement of the riverbed towards the right bank is highlighted. The image taken in 2023 shows the protection works of the right bank in the area where the adduction pipeline is located. Also, the stability of
