MONITORING OF DEGRADATION PROCESS OF THE SHORE DEFENCE WORKS IN ERODABLE RIVERBEDS

Prof. PhD.Eng., MIHAIL LUCA Technical University "Gheorghe Asachi" of Iaşi Romania Stud.PhD.eng., PAUL - VIVIAN SION, stud.PhD.eng. MIHAELA AVRAM stud.PhD.eng. ŞTEFANIA CHIRICĂ, Doctoral School, Technical University "Gheorghe Asachi" of Iaşi

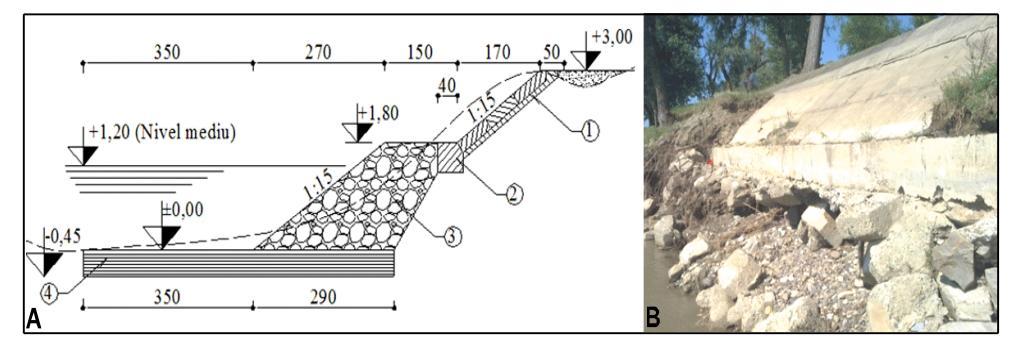
Fig. 3. Images of the shore defence on the Moldova River A - execution pattern for type A1; B - detail on the state of exploitation of shore defence on the Moldova river, Soci area in 2010.

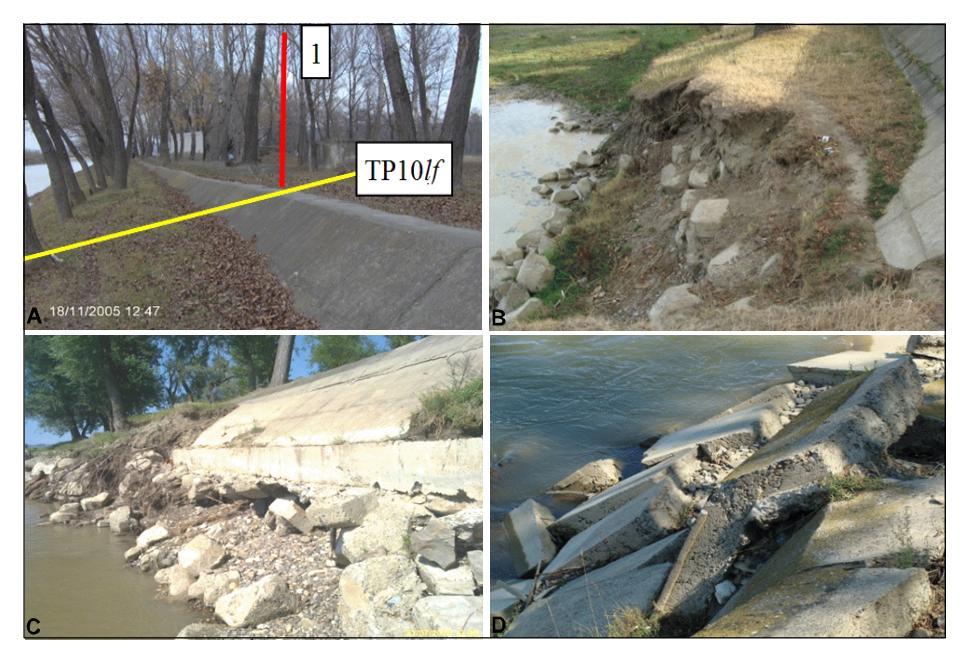
The degradation of the shore defence works was carried out by destructive processes during the years 2000 - 2015. The degradation process included the following steps: a - washing the alluvial offshore defence (Fig. 4.b); b - removing the cement mortar from the joints and washing the ballast layer under the tiles (Fig. 4.c); c cracking and cracking of concrete slabs; d the entrainment of the rock from the supporting mass and the collapse of the defence building; e - breaking of the support beam and the collapse of the concrete slabs (Fig. 4.d); f - the drilling of concrete pieces in the riverbed and the erosion of the bank (Luca 2012, Luca 2016).

Fig. 4. State of decay in time of the bank protection

A – the situation of defence works in 2005 year of the left transversal profile number 10, TP10lf;
B – silt washing in the 2008 year;
C – degradation of tiles, 2010;
D – training tiles and collapse into bed in the 2012 year.

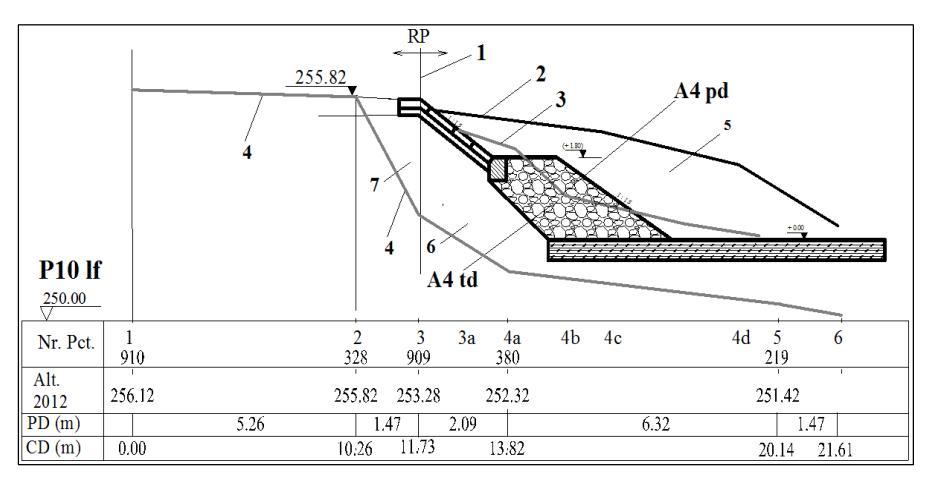
Fig. 5. Analysis and calculation scheme of the erosion phenomenon in the left bank of the Moldova river, transversal profile TP10 left

reference point 2; 2 - shoreline in 2006; 3 - the bank line in 2008; 4 - shoreline in 2012;
layer of alluviums; 6 - shore erosion area; 7 - erosion area in minor bed; A4 – type A4 bank of defence; A4 pd - partly degraded shore defence; A4 td - total degraded shore defence.

The topographic monitoring mode for a research section is presented in Figure 5, where three topographical measurements made in 2004, 2005, 2006, 2008 2010 and 2012 in the TP10lf transverse profile are highlighted.

Period	2004	2005	2006	2008	2010	2012	2014
<i>L</i> (m)	18.42	17.21	16.11	13.91	12.88	- 1.47	- 1.92
Her (m)	-	-	0.42-0.69	1.76-1.93	2.27-3.05	2.88-4.12	3.28-4.80
Obs.	-	-	-	D.p.ap.m	D.p.ap.m	D.t.ap.m	Er.m.
D.p.ap.m partial shore defence degradation; D.t.ap.m - total shore defence degradation; Er.m the river bank erosion

Table 1. Monitoring of erosion parameters - TP10If Moldova River

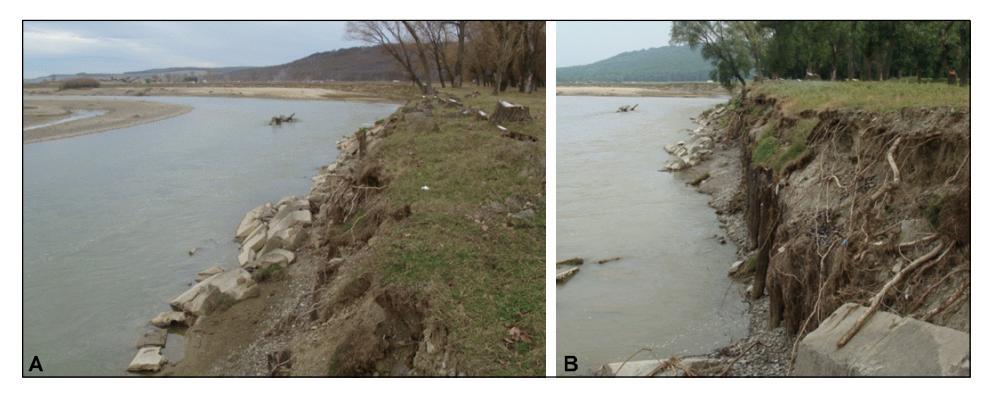
Natural risk factors, corroborated with those of anthropogenic risk, have accelerated the degradation of shore defence works until their total destruction. The shore defence works were more degraded on the left bank, where the phenomenon was accelerated by two anthropogenic risk factors: a exploitation of river bed ballast in the upstream section of the research sector; b - absence of maintenance and repairs works of the shore defence.

Fig. 6 - General view of the total degradation of shore defence and left bank erosion of the Moldova River in the research area

A - the left bank, the upstream area, the year 2014, the profiles TP1If -TP6If; B - left bank, central area, 2014, profiles Pt8I - Pt11I.

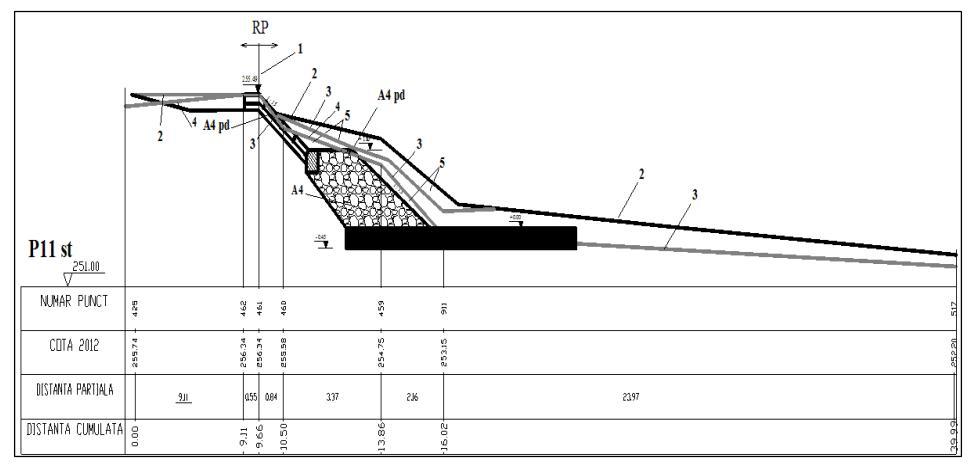
Similarly, the data for the other cross-sections were processed. Some profiles were recorded during the research period only by the erosion of the alluvial deposit, for example the TP11lf profile (Fig. 7).

1 - reference point 2; 2 - shoreline in 2006; 3 - the bank line in 2008; 4 - shoreline in 2012; 5 - layer of alluviums; 6 - shore erosion area; A4 - type A4 bank of defence; A4 pd - partially degraded shore defence.
