CONSIDERATIONS REGARDING ECOLOGICAL RESTORATION OF DEGRADED RIVERBED

*Stud.PhD.eng. PAUL VIVIAN SION, prof. PhD.eng. MIHAIL LUCA,
stud.PhD.eng. STEFAN ANDREI STICEA
Technical University "Gheorghe Asachi" of Iași, Romania*

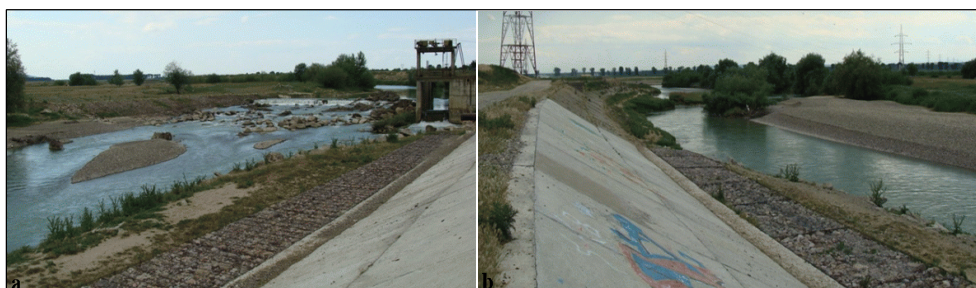
Fig. 2. Main river/ left arm of the Moldova River in the catchment area
 a - status of the catchment in the catchment area;
 b - the status of the downstream catchment [Luca et al., 2019]

- riverbed is calibrated on a length of 320 m, with a cross section of trapezoidal shape; flow regularization is performed with a bottom threshold, energy sink and a rhizome;
- the left bank is protected by reinforced concrete slabs;
- the right bank is protected by the beds of gabions filled with river stone;

- the depths of the water are variable (0.5 -2.5 m), with high speeds, situation that does not allow to ensure the living conditions for the aquatic fauna and flora.

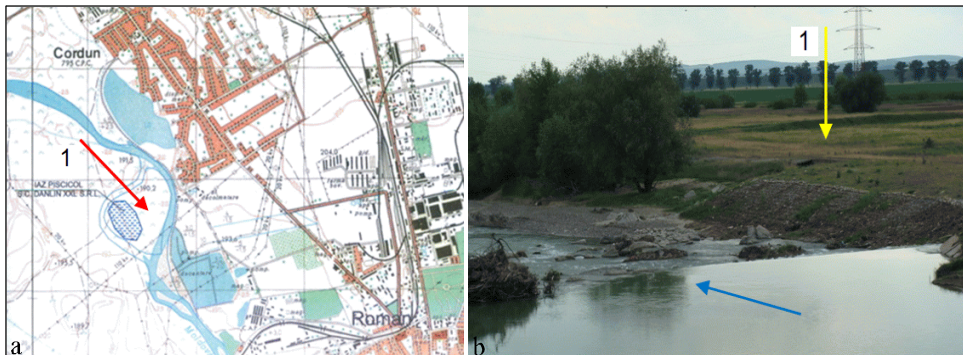
- the path of the right arm is curved, with a natural bank fed intermittently, more at high flows;
- between the two arms of the river an island was formed, with a land taken on the left bank occupied with agricultural crops (Fig. 3.b);
- the secondary bed has a variable width, being morphologically modified at floods by erosion and clogging phenomena (Fig. 4);
- in the secondary riverbed there are alluvial formations that block the flow of water;
- at the entrance to the riverbed there is an improvised drainage threshold, which limits the access of the water to small flows (Fig. 5); Prior to joining the main riverbed, an improvised stone spillway threshold is intermittently made (Fig. 5);

Fig. 3. Characteristics of the location of the island and the secondary riverbed
a - the situation map of the island; **b** - general view of the island (1) from the catchment area on the left arm [Luca M., et al., 2019]

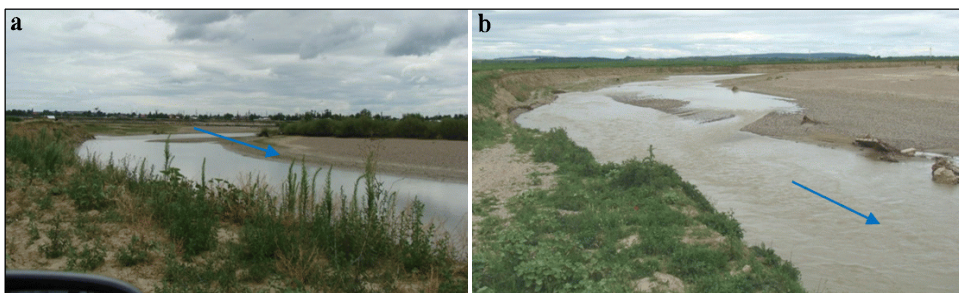
- the water depths are small, with very low speeds, and in some areas the water stagnates with the generation of anaerobic phenomena and degradation of the aquatic environment;

Fig. 4. Overview of the island and the secondary bank from the NW
a - shore erosion and alluvial deposits; **b** - alluvial deposits on the central sector of the riverbed [Sion, 2019]

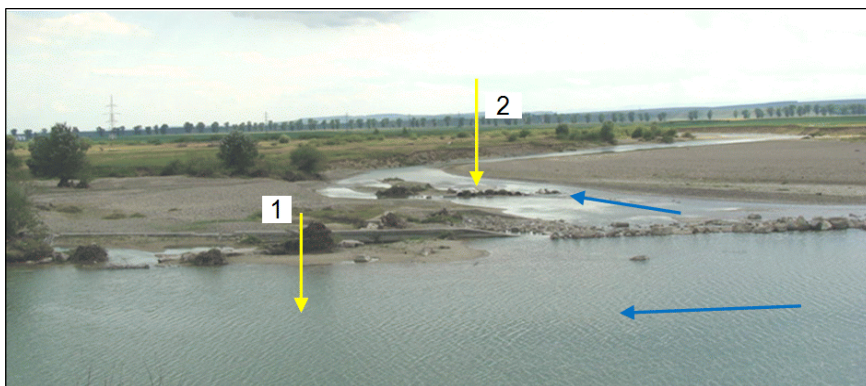
Fig. 5. General view of the bifurcation zone of the two banks of the whole Moldova river of the island
 1 - main riverbed; 2 - secondary riverbed with the improvised spillway threshold (Sion, 2019)

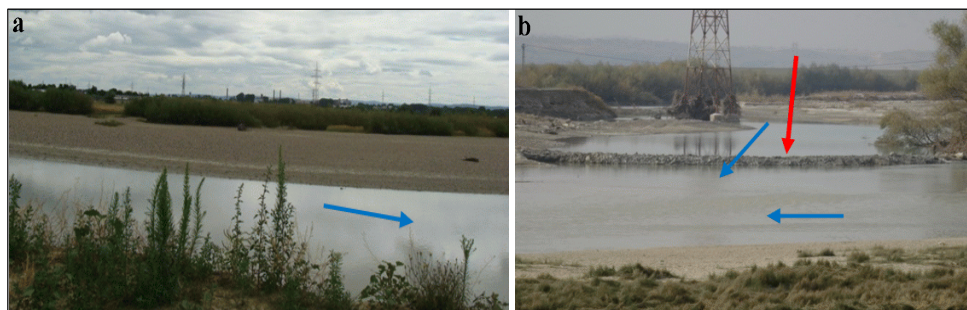
Fig. 6. Morphological elements of the secondary riverbed

a - the final sector of the riverbed; b - the improvised threshold in the final section of the secondary riverbed at the junction with the main riverbed [Sion, 2019]

c - carrying out a hydrotechnical construction comprising a spillway threshold and a dock in the final section of the riverbed with dimensions and characteristics that allow the evacuation of a controlled flow from the secondary riverbed;

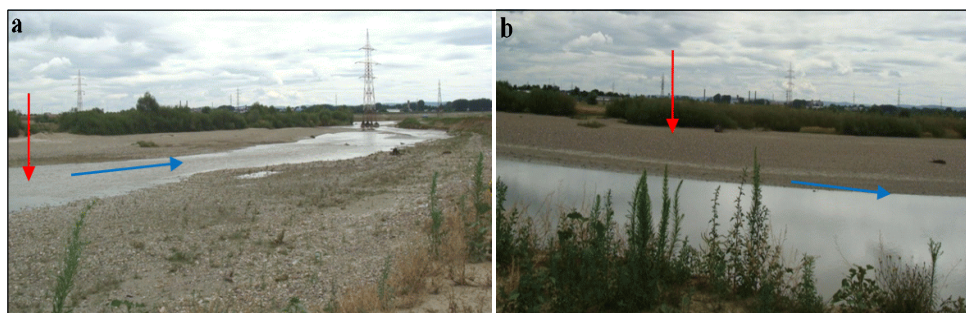
Fig. 7. Ecological restoration area of the Moldova River secondary arm in the Cordun area
a - the entrance sector; **b** - central sector with highlighting the deposit areas (Sion, 2019)
