THE INFLUENCE OF TREES IN THE MINOR RIVERBED OVER THE WATER FLOW AND STABILITY OF THE RIVERBED. CASE STUDY

Assoc.prof. COSTEL BOARIU
Technical University "Gh. Asachi" of Iași, Romania

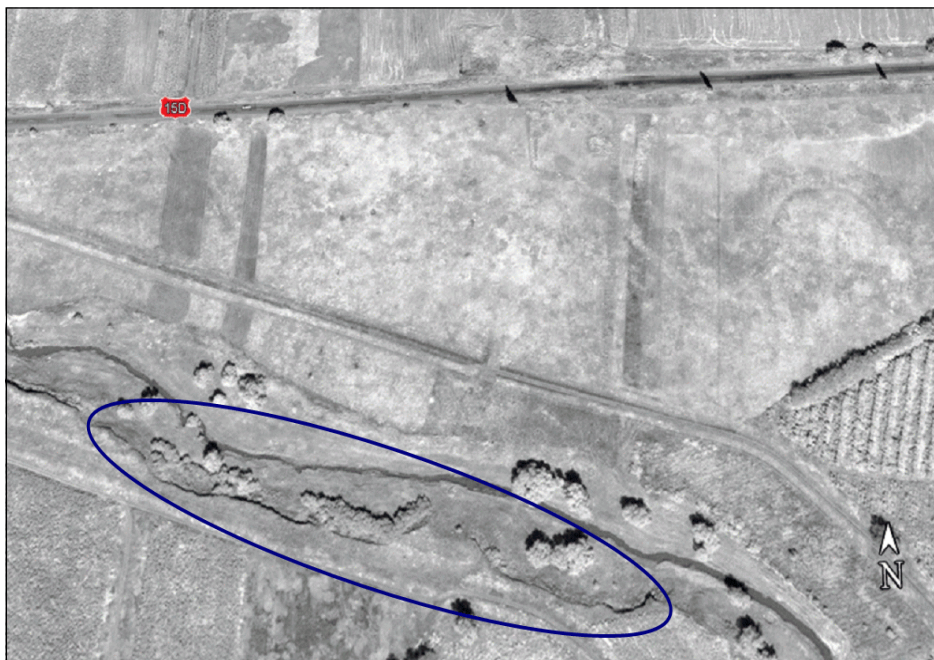
Fig. 3. Eroded area in 2010

According to the class of importance the sizing of the dikes was done for the flow with the probability of 5%. In the forest area Lunca Dumești the river Bârlad is arranged with protective dikes on the ground on both banks. In this area there is an erosion of the right bank partially stabilized with vegetative works (acacia plantation). As seen in the sequence of images, the right bank erosion has been initiated since 2010.

In time, the manager of the riverbed planted acacia trees in the eroded area to stop erosion. As shown in the sequence of images from 2010 to 2019 (fig. 3-6) the area planted with acacia has expanded but the erosion of the riverbed has not ceased. On the contrary it extended to the right bank

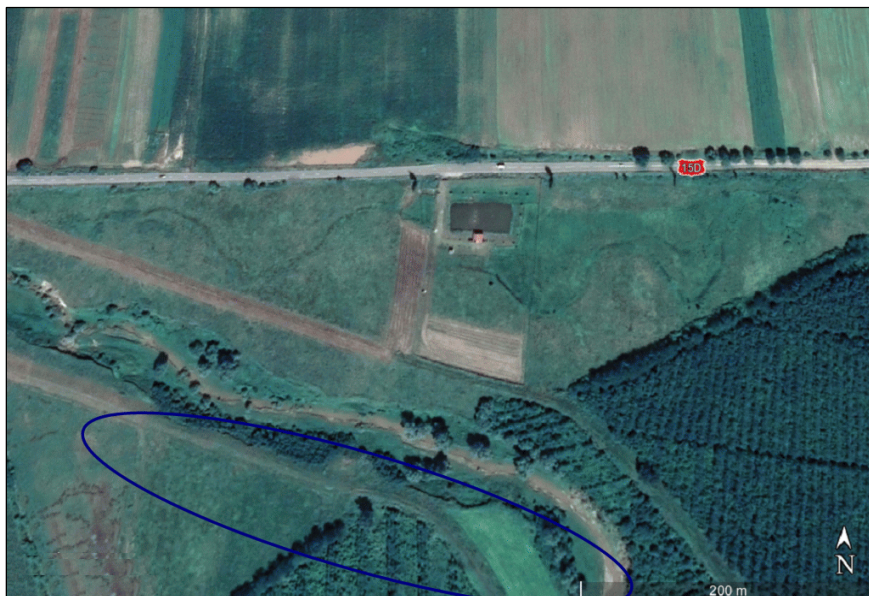
Fig. 6. Eroded area in 2019

dam and in the area of the crown. It turns out that planting trees in the riverbed is not a solution in itself.
