RESEARCH ON THE INTERCONNECTION OF THE MINOR RIVER BED WITH THE RIPARIAN AREA

*Stud. PhD. PETRONEL-IONUT ROMANESCU, stud. PhD. PETRU-DANIEL BRĂNIANU
prof. PhD.eng. MIHAIL LUCA
Technical University „Gheorghe. Asachi” of Iasi, Romania*

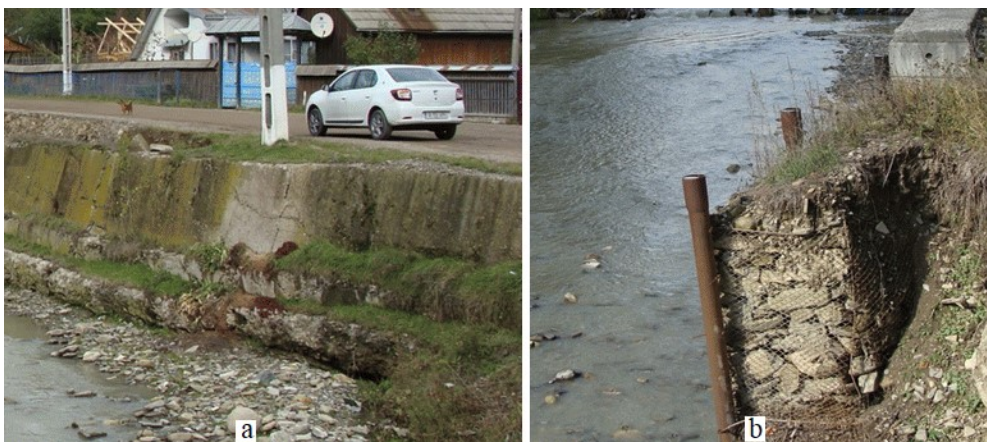
Fig. 2. Tazlăul Sarat River bed interaction - riparian area: a - degradation of the bed and the county road, Chiosa area; b – the degradation of the riverbed and the county road in the "Maxim's canton" area (Luca M., 2016)

- the minor bed is relatively rectangular in shape, being formed in a layer of coarse alluvium, under which large stones and pieces of rock appear (Fig. 2);
- rapid floods with high flows frequently occur, which exceed the calculation probabilities of regularization and shore defence works;
- high water speeds generate intense erosion phenomena of the flow section;
- the regularization of the bed has been

partially achieved, the shore defence is placed only on the protected sections; the shore defence is made of plain concrete walls (Fig. 2.a), reinforced concrete slabs and gabion boxes filled with stone (Fig. 2.b);

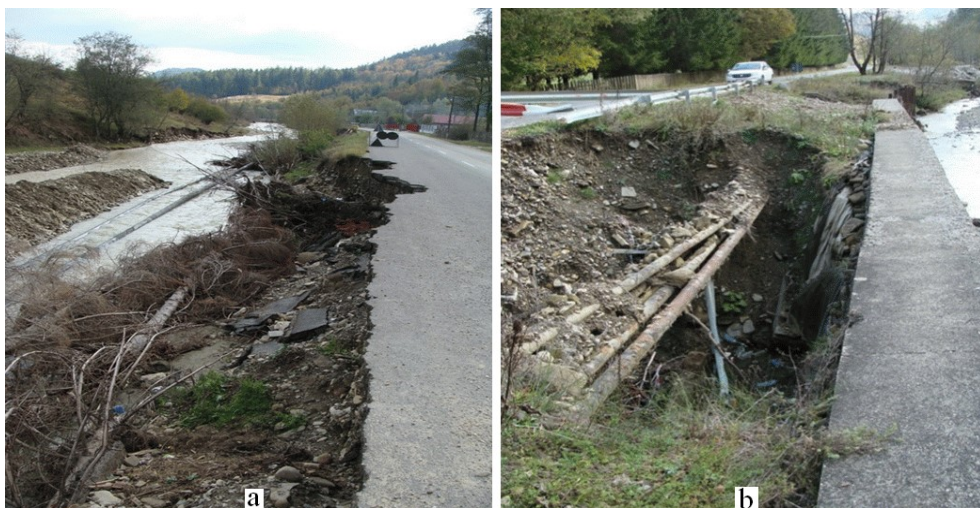
Fig. 3 Tazlăul Sarat River bed interaction - riparian area: a - degradation of the bed and the county road, Chiosa area; b – the degradation of the riverbed and the county road in the "Maxim's canton" area (Luca M., 2016)

The flood produced in June 2016 on the Tazlăul Sărat River produced multiple phenomena of erosion of the bed and the riparian area related to the section that crosses the localities of the Zeme commune (Todera, Hartopan, Chiosa and Zeme). Erosion occurred vertically and horizontally in the bed. The vertical erosion exceeded the elevation of the foundation of the shore defense in the areas of Chiosa (Fig. 3.a) and Maxim's Canton (Fig. 3.b). This situation allowed the penetration of the water jet under the bank defense in the Maxim Canton area and the erosion of the resistance structure of the riparian road (Fig. 3.b). The horizontal erosion determined the destruction of the bank defense and the advance of the bed in the bank (Fig. 3.a).

Also, the erosion of the bed and the bank determined the uncovering of pipelines for transporting technological fluids (Fig. 3) and the risk of water and land pollution with petroleum products. The analysis of data collected from the field and processed over a period of time revealed a strong influence of natural risk factors, which are predominant over anthropogenic ones in the research area on the Tazlăul Sărat River.

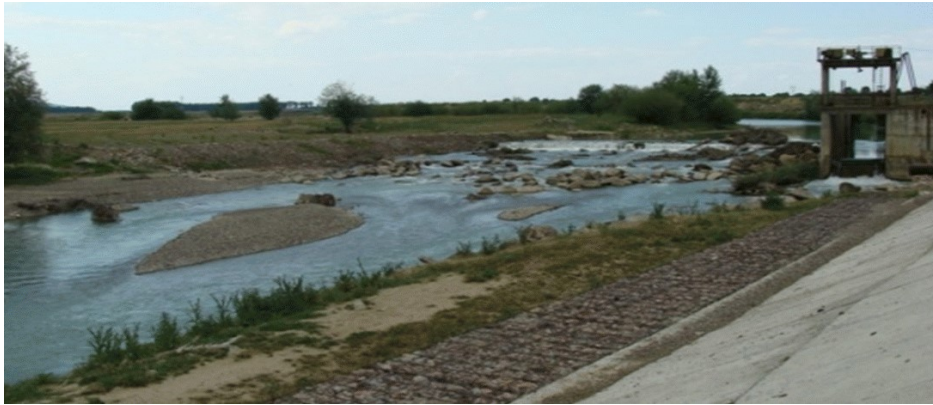
Fig. 4. General view of the bed section on the Moldova River with the water catchment and in the riparian area (photo Luca M., 2020)

Case study II. The interconnection of the minor bed of the Moldova River with the riparian zone on the territory of the Cordun locality in Neamt county. The lower course of the Moldova River is characteristic for the area of high hills, where the elevation of the land is between 400 - 600 m. The analysis of the research area highlighted the following characteristics of the Moldova River bed (Fig. 4, Fig. 5) (Luca M., 2011):

The riparian zone on the research sector presented the following characteristics (Fig. 4, Fig. 5) (Luca M., 2011):

and a series of hydrotechnical constructions located in the bed: in this situation, the bed became a channel for the rapid transit of the water current (Fig. 4);

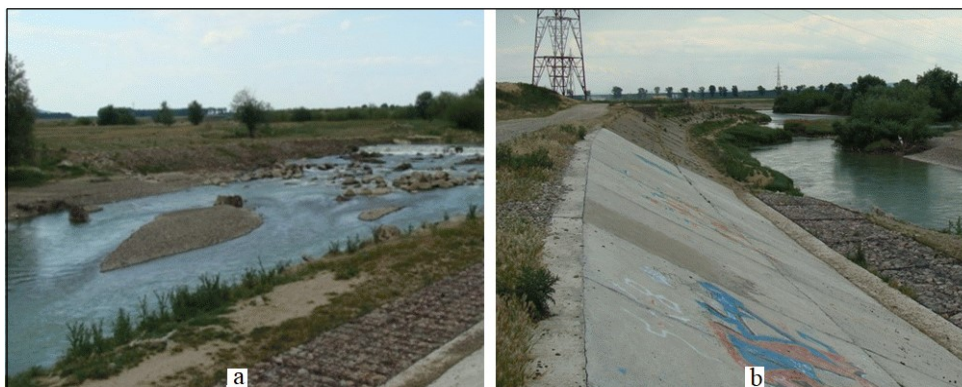
Fig. 5. Moldova River bed interaction - riparian area: a - condition of the bed in the area of the water catchment construction; b – the state of the riparian area, the left bank protection and the downstream catchment bed (photo Luca M., 2020)

- the lack of works to rehabilitate the water catchment, but also of the shore defence, contributes to the continuous degradation of the environment (Fig. 5).

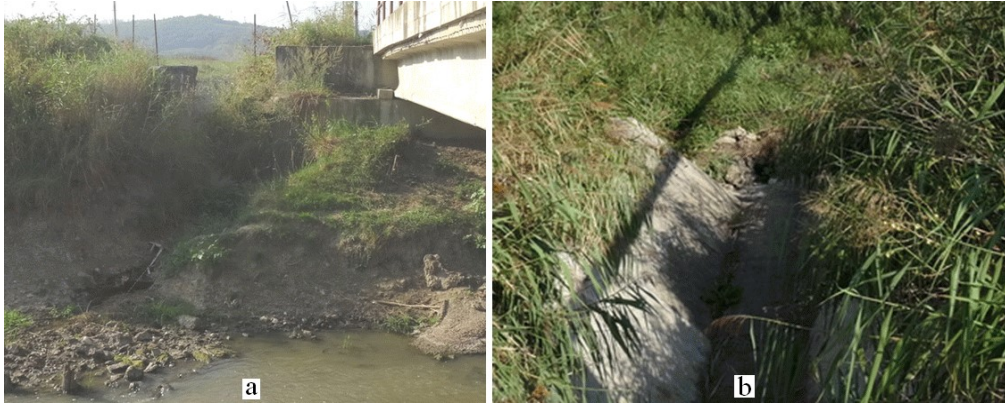
Fig. 7. Bahlui River bed interaction – right bank riparian zone: a – bank erosion by the degraded state of DC4; b – the degradation state of DC1 (Luca M., 2019).

built in the middle (Fig. 7.b);

and DC4 are located near the bridges (Fig. 7.a), and DC2 and DC3 on the right slope of the research section (Fig. 7.b).

- the discharge construction DC4 is partially degraded on the final section; the analysis carried out in the field revealed the loss of stability of the exhaust channel due to the suffusion phenomenon formed in the foundation and the supporting soil layer of the construction;

- the outlet channel at DC4 broke into pieces, and the transported rainwater eroded the riparian area and the river bank; the shore protection in the area of the evacuation construction was totally destroyed (Fig. 7.a); due to the faulty operation of the drainage construction, the hydrodynamic erosion of the bank also occurred, and the river bed advanced into the bank;

- the outlet channel at DC1 is totally degraded on the cooling section with the Bahlui river, so that the rainwater discharges directly onto the river bank and causes its erosion;

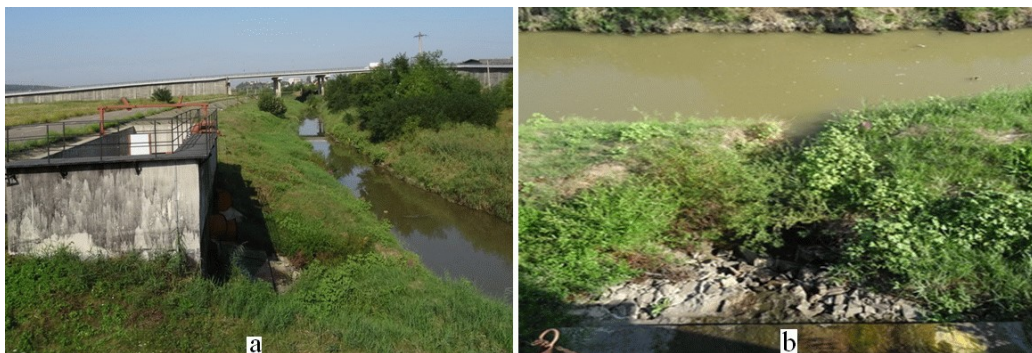
Fig. 8. Bahlui River bed interaction - right bank riparian area: a - rainwater storage tank and discharge with DC2 in the bed; b – overview of degraded structural states of DC2 (year 2019) (Luca M., 2019)

- the discharge channels at DC2 and DC3 are partially degraded (Fig. 8), a situation in which the water is discharged directly onto the river bank.
