VERIFICATION OF TOPOGRAPHIC DRAWING PARAMETERS OF WATER OUTLETS AT EARTH DAMS

*Prof. PhD. eng. MIHAIL LUCA, VIOLETA DOMINTE (CROITORU),
as. prof., PhD. eng. NICOLAE MARCOIE, IOANA AGAPIE (MEREU)
Technical University „Gh. Asachi” of Ia i, Romania*

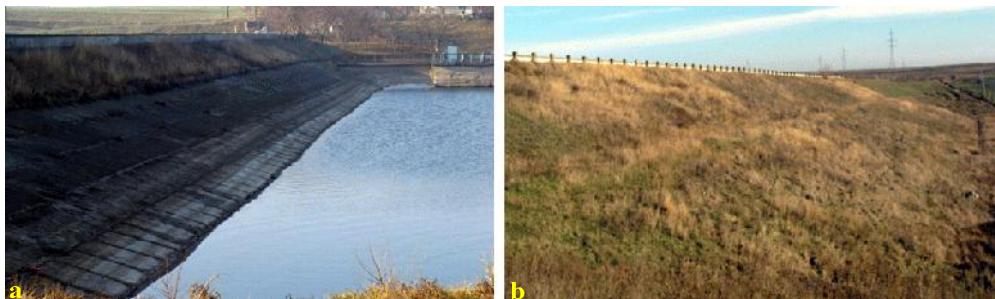
Fig. 2. General view of the Chirita dam
a - upstream facing; b - downstream facing

219 m, a canopy width of 6.0 m and a maximum height of 5.0 m. The upstream facing is protected with concrete slabs measuring 1.0 x 1.0 x 0.15 m. in the area of variation of the exploitation level (Fig. 2.a). At the base of the downstream facing is a filtered mattress made of broken stone (Fig. 2.b). The dam is provided downstream with an infiltrated water drainage system from the lake (Luca et al., 2004).

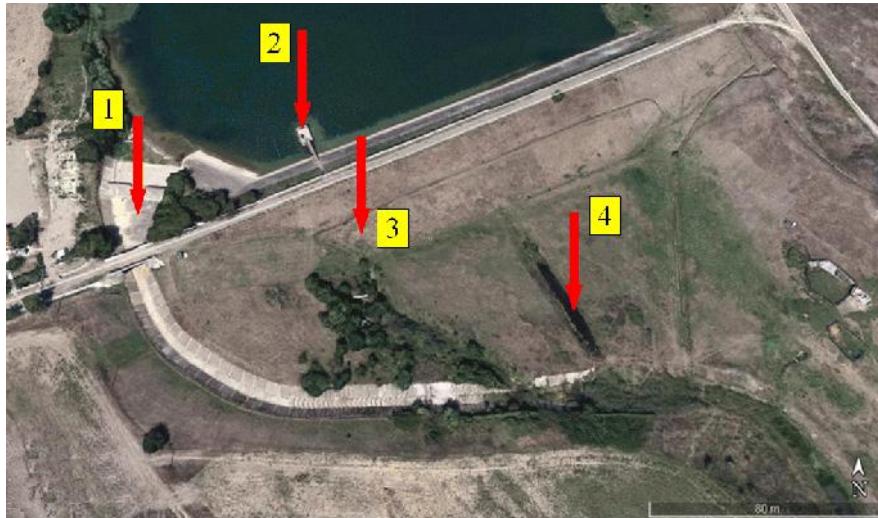
Fig. 3. General view of the location of the outlet structure at the Chiri a dam
 1 - the high water discharger; 2 - manoeuvring tower and socket;
 3 – unwatering conduit; 4 - sewerage drainage
 (Luca et al., 2004, image Google earth, 2010)

Chirita Dam is equipped with two constructions for outlet structure water from the lake. The evacuation of the average flows is performed and adjusted at the same time with a control tower and socket connected to a watering conduit. The manoeuvring tower is equipped with cofferdams and water intakes connected to diversion pipes to the consumer (the water supply system of Iasi). The transit of large flood flows, taken over by the accumulation lake, is done with evacuator water. It is a canal type, being located on the right side of the dam and connected downstream to Long Valley Stream (Fig. 3).

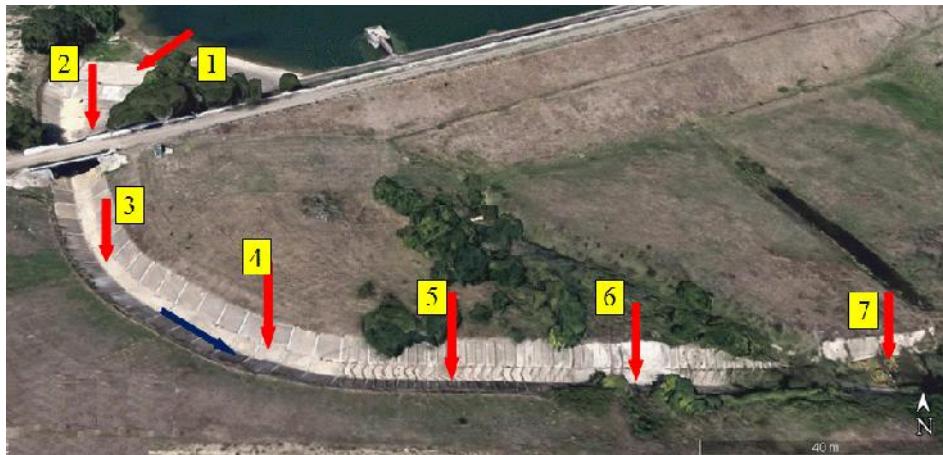
Fig. 4. General view of the high flow evacuator

1 - access channel; 2 - spillway; 3 - connection channel; 4 - inclined drop zone 1;
 5 - inclined drop zone 2; 6 - hydraulic energy dissipater + downstream apron;
 7 - escape channel (image Google earth)

The evacuator is composed of the following structural components (Fig. 4): overflow access channel (CA); thick-walled overflow and triangular cross section continued with hydraulic energy dissipater (D + CD1); connection channel (CL) (Fig. 5.a); inclined drop (CR) (Fig. 5.b); hydraulic energy dissipater and downstream apron (D); evacuation channel and connection to Long Valley stream (CE). The channel is made of excavation and is protected by reinforced

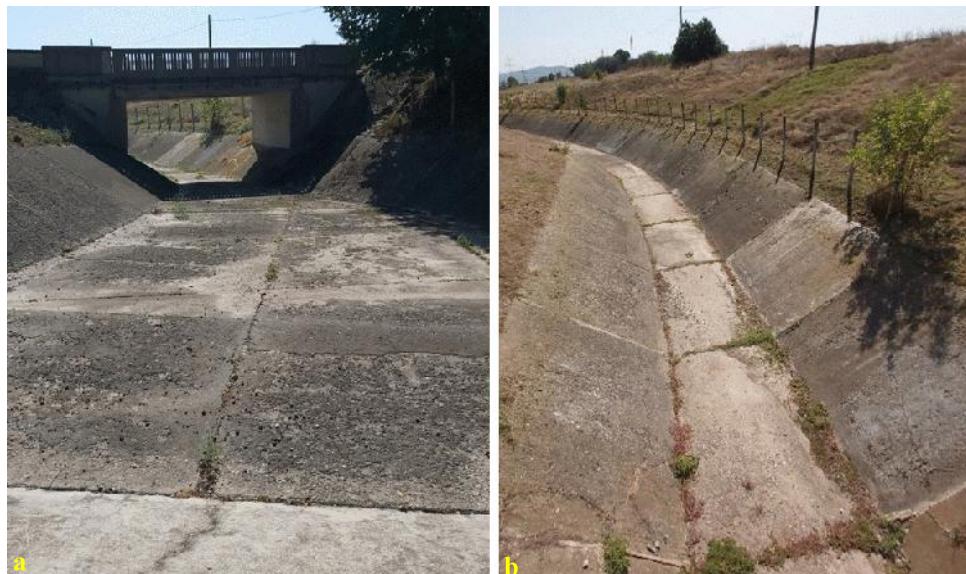
Fig. 5. The state of the flow section of the high flow evacuator
 a - connection channel (CL); b - inclined drop (CR1) (Luca et al., 2009).
