CONSIDERATIONS CONCERNING THE HYDRAULIC YIELD OF IRRIGATION PLOTS UNDER PRESSURE

*PhD.eng. ALEXANDRU - LUCIAN LUCA, Polias - Instal Company, Iași Romania
Stud.PhD.eng. ȘTEFAN - ANDREI STICEA, Profesor, PhD.eng. MIHAIL LUCA
Technical University "Gheorghe Asachi" of Iași, Romania*

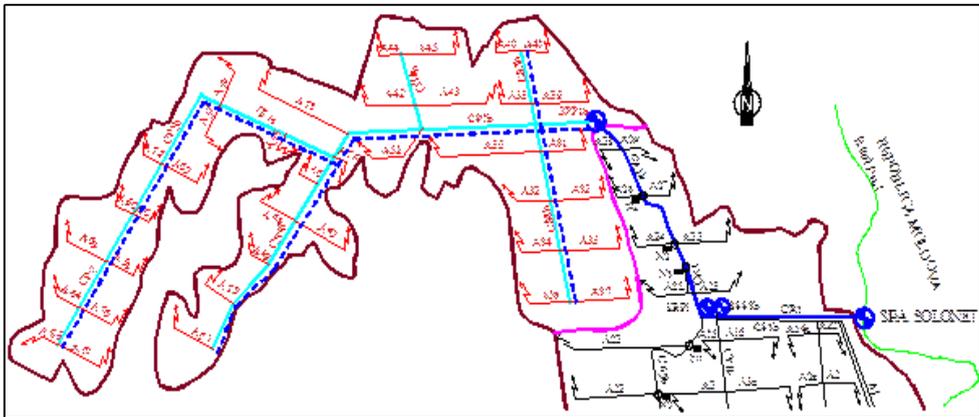
Fig. 6. Initial scheme for the irrigation plot SPP1b Sud Solonet

A case study was prepared for the SPP1b Irrigation Plot South Solonet System (Fig. 6), regarding the hydraulic efficiency of the

continuous line - high pressure pipelines; dashed line - medium pressure pipelines (Luca, 2012)
