## RESEARCH ON THE DEGRADATION OF PIPELINES POSITIONED IN THE UNDERCROSSING OF RIVERS

*Prof.PhD.eng. MIHAIL LUCA,  
stud. PhD PETRU-DANIEL BRANIANU, stud. PhD PETRONEL-IONUȚ ROMANESCU  
Technical University „Gheorghe Asachi” of Iași, Romania*

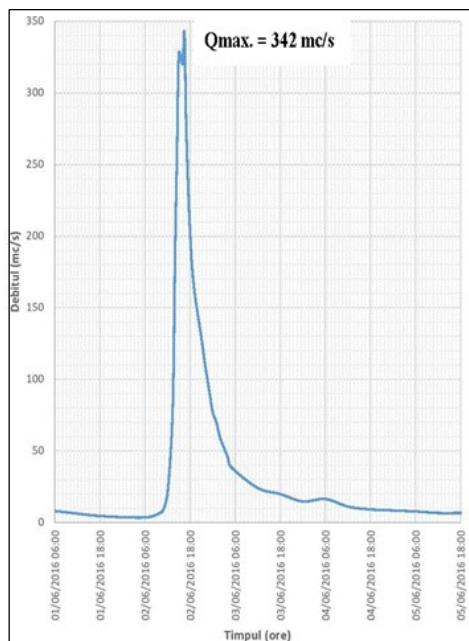
of 69 cm and a flow rate of 6.70 m<sup>3</sup>/s, values measured at S.H. Lucacesti. The peak of the flood was recorded at S. H. Lucacesti on 06/02/2016 at 16:30, where the maximum height was 360 cm, and the maximum flow reached 342 m<sup>3</sup>/s [Table 2]. The flow increased about 50 times in a time interval of about six hours. The probability of exceeding the maximum flow rate was 3% in the control section [Fig. 2]. The flood spread of 2.73 m exceeded the banks on some of the middle and lower reaches of the Tazlaur Sarat River [Luca M., Avram M., 2017, WAB Siret, 2016].

Fig. 2. The flood hydrograph recorded at the Lucacesti HS (W.B.A. Siret, 2016)
